Coolibah Plains, 694 Comet downs Road, Comet Queensland 4072

Initial Survey/Scope of Works

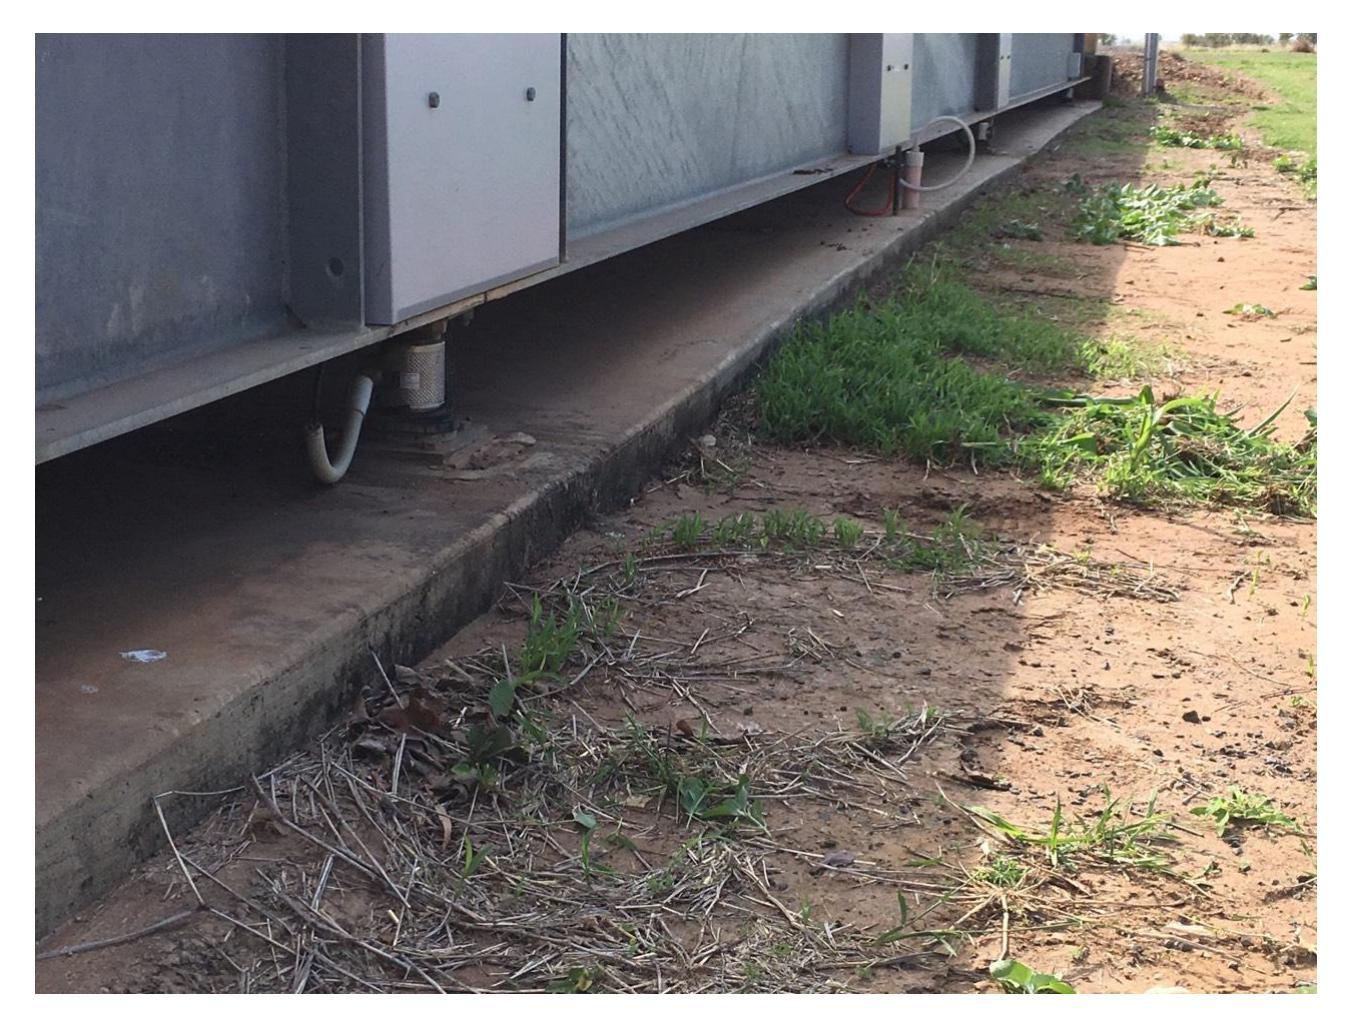
The client's installed weighbridge had become inaccurate, and not able to be re-calibrated. Upon investigation, the 500mm x 500mm x 4000mmL bearing beams supporting the load cells have been found to be subsided/undermined by approximately 15mm. The 15mm subsidence was measured via dumpy level and supplied by client. Upon physical inspection of the weighbridge by Slab Jack Industries, the affected beams were found to be -12mm & -14mm from datum.

Weighbridge before, note deflection on bearing beams under load cells (especially rear most)

Slab Jack Industries proposed raising and re-levelling the bearing beams using Contite Slab Lift. Through careful analysis of supplied information and the clients clearly communicated requirements, the criteria for success was to be measured against the following benchmarks;

- Levelling the affected beams longitudinally to within 5mm tolerance
- Stabilising the beams using Contite PUE500/501
- Asset downtime of 48 hours
- Physical testing of weighbridge for operational accuracy post works
